ARECIBO OBSERVATORY
P U E R T O R I C O
U C F • Y E I • U M E T

AOSSC REPORT & RECOMMENDATIONS

Arecibo Observatory Survey Salvage Committee
Arecibo, Puerto Rico
March 25 2022

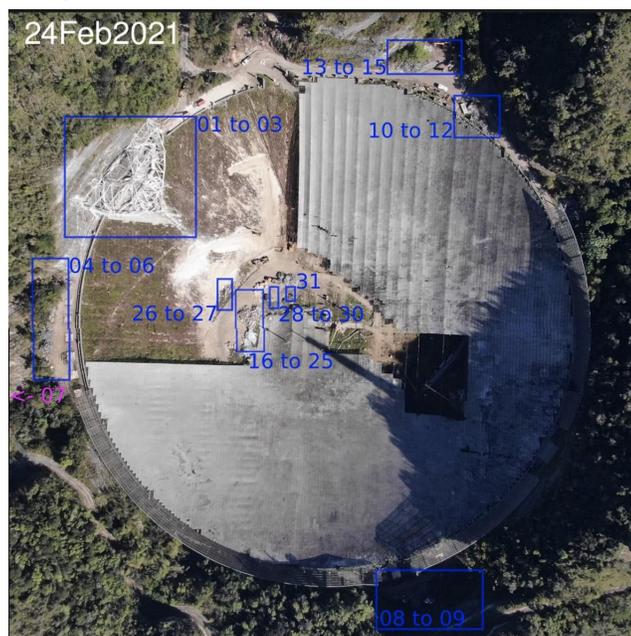
Figure 1. Drone survey picture of the primary reflector. Rectangular markings on the image denote areas with potential material to be recovered. The numbers next to the rectangular areas correspond to more detailed pictures of the area. Image taken 20210224.

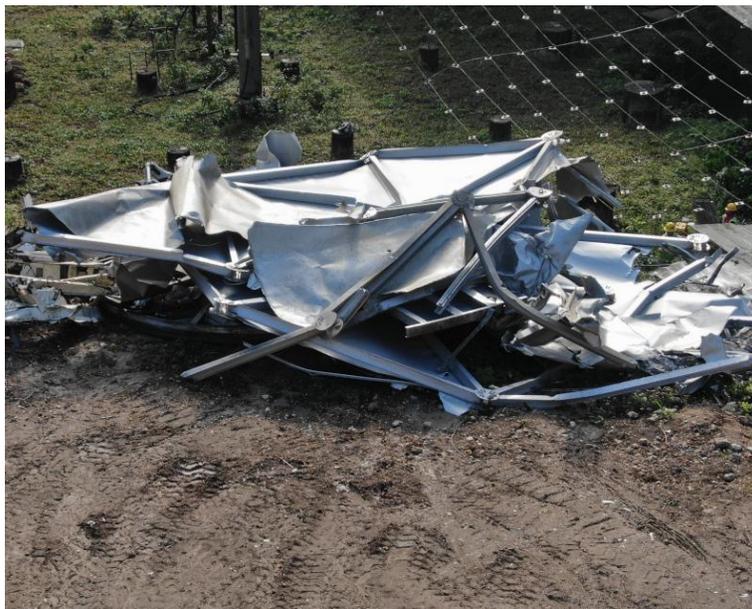
Figure 2. Drone survey picture No. 23 showing Gregorian Dome shell.

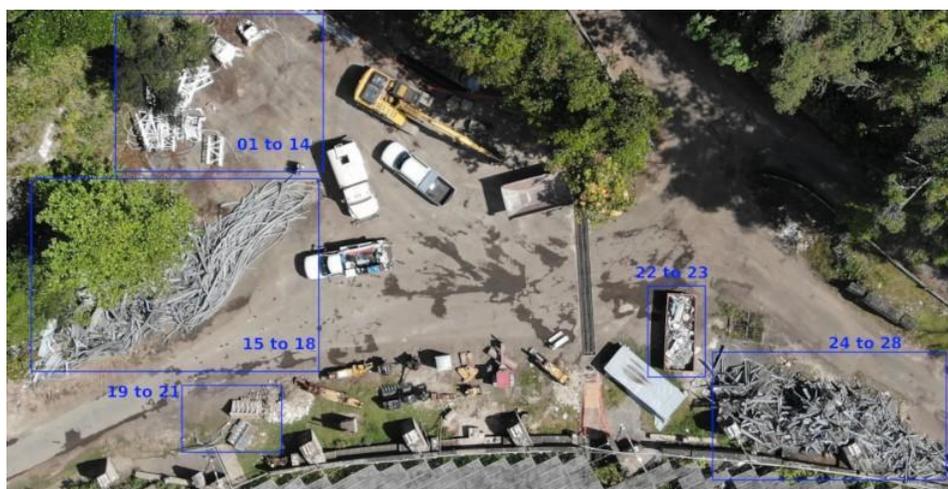
Figure 3. Drone survey of the VIP Area. This was historically the “VIP” area at the north-east edge of the primary reflector. This drone survey was performed on 26 Feb, 2021.

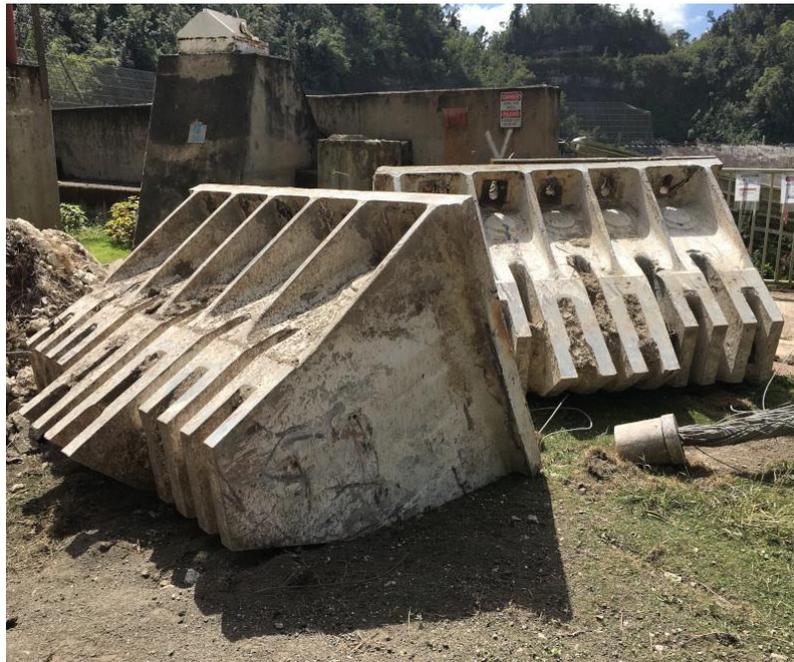
Figure 4. Field visit survey picture No. 20 shows two tower saddles located at the top of the telescope towers. Each saddle supported the cable ends going to the platform on one side and the backstay cables to the anchors.

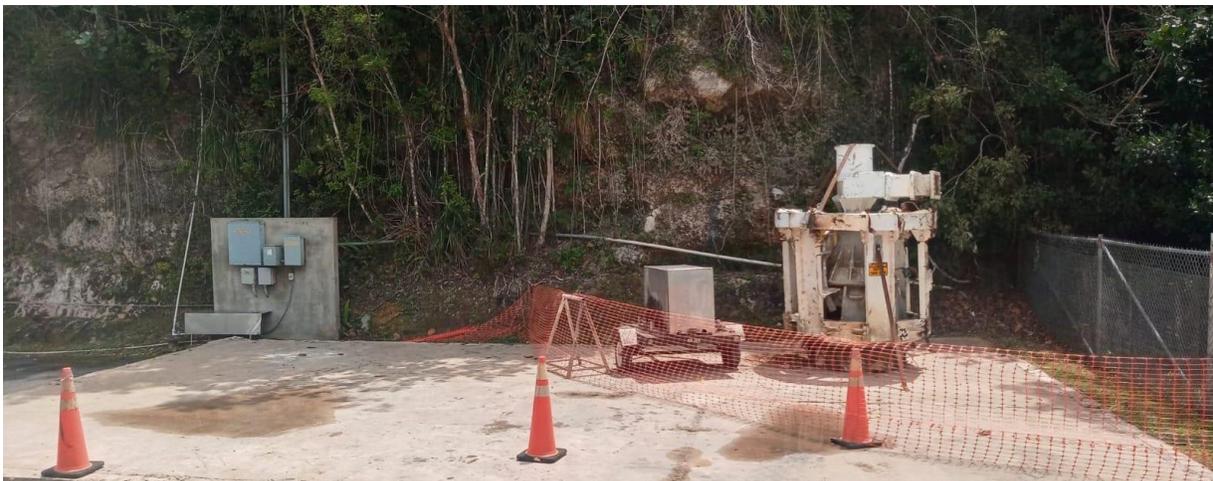
Figure 9. Current location of Rotary Joint, item No. 0044, proposed location for permanent display.

Small pieces are mostly located at the Building 1 Control Room Parking area. Big pieces are mostly at the warehouse, diesel generators, or staging area. These areas are identified in Figure 5. The Building 7 area is halfway between the Visitor Center and the collapse site. The long-term recommendation is to place big pieces, like the 430MHz transmitter rotary joint, there for display.
