Washington Metropolitan Area Transit Authority Hi-Rail
Maintenance Vehicle Strikes Two Wayside Workers Near the
Rockville Station
Rockville, Maryland
January 26, 2010

Accident Summary Report

NTSB/RAR-12/04/SUM
PB2012-916304

Railroad Accident Report

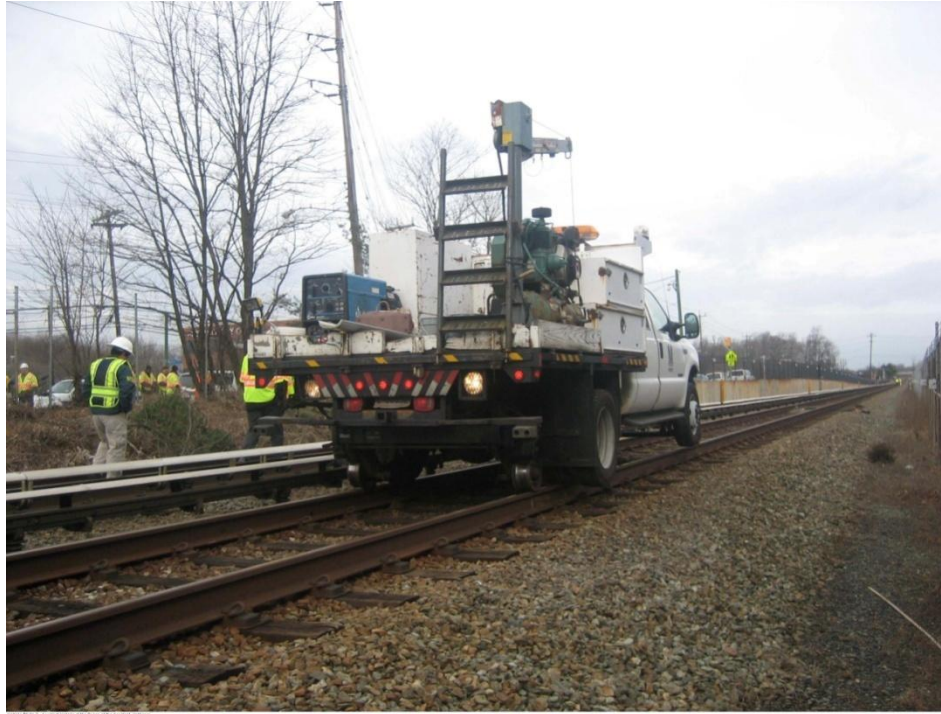
Figure 2 shows the hi-rail vehicle at the location of the accident.

Figure 2. The striking hi-rail vehicle at the accident location.

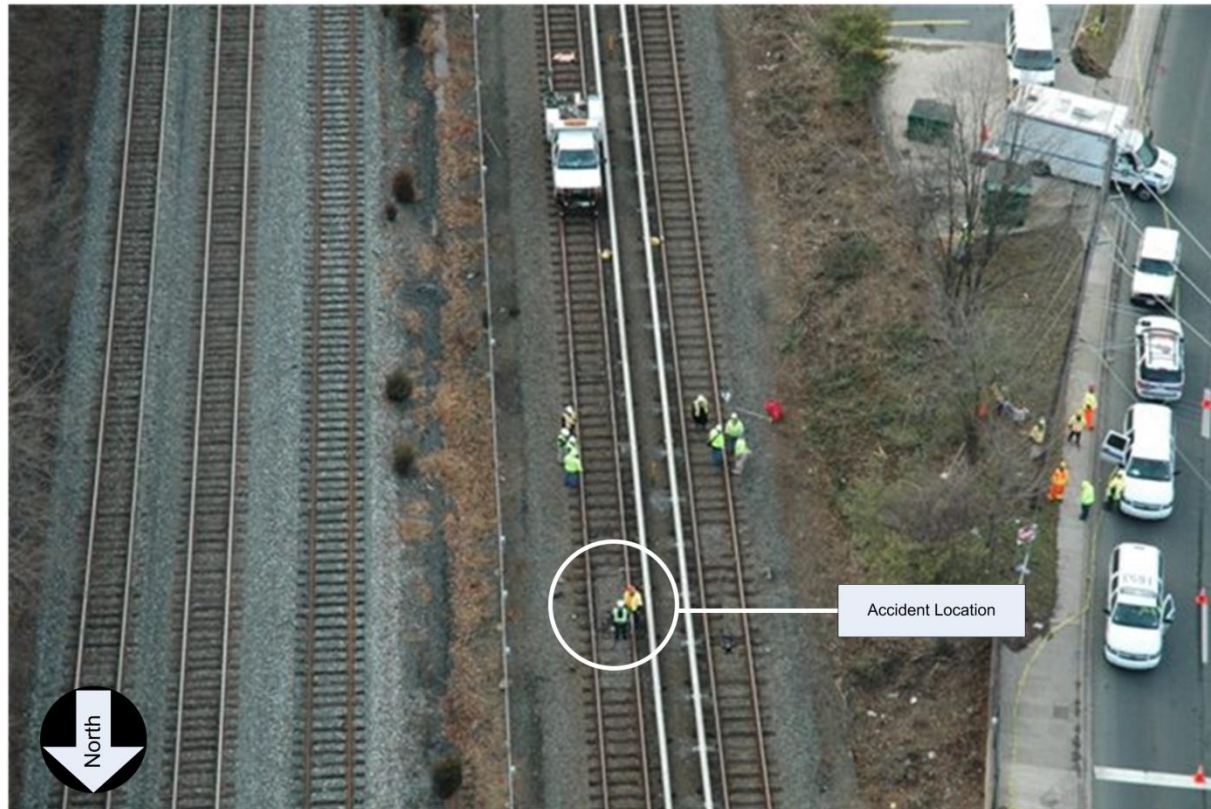
The next radio transmission from hi-rail vehicle 15802 was the initial notification of the accident, made to the OCC at 1:40:34 a.m. Figure 4 shows the accident location.

Figure 4. Aerial view of the accident location.

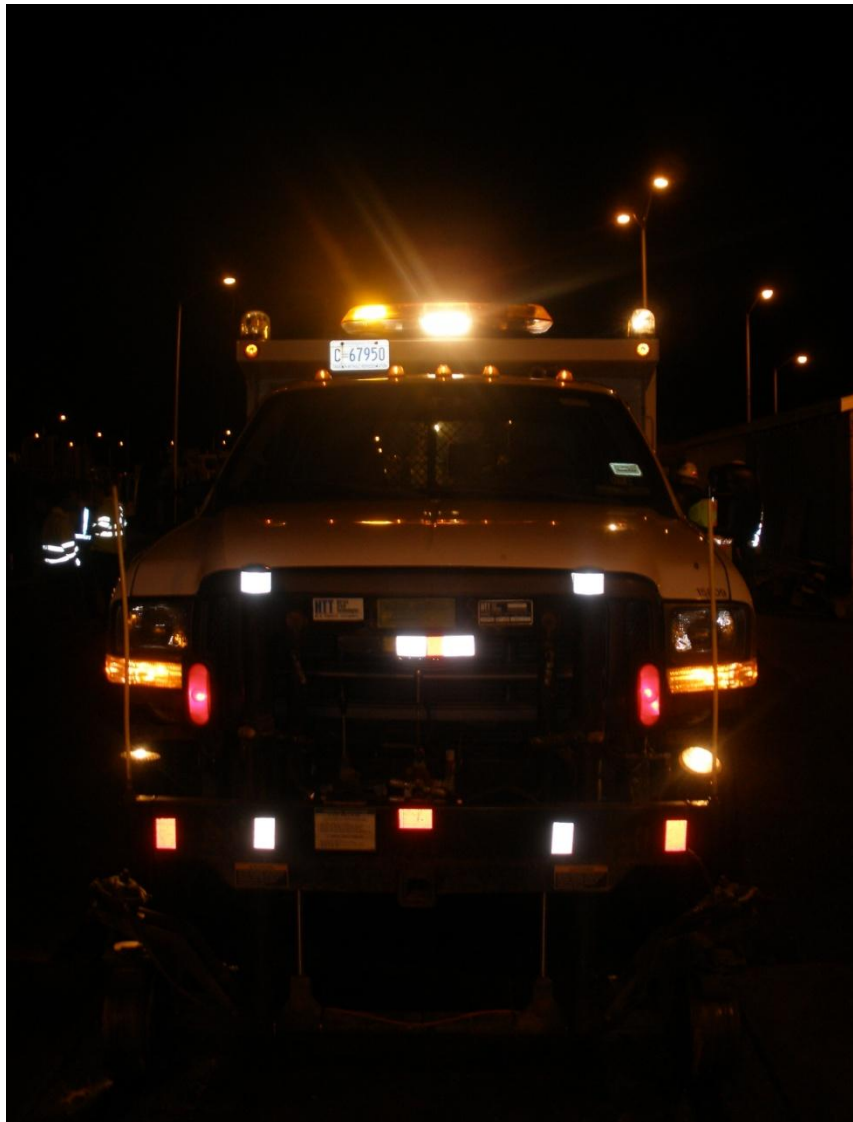
Figure 5. Front view of a hi-rail vehicle with the upgraded lighting package.

WMATA has also implemented a program to upgrade from its standard headlights and quartz lights on hi-rail vehicles to high-intensity xenon lights, which will improve lighting for both night work and tunnel work. The upgrade will provide three times the amount of light and should have an extended illumination of 1,475 feet in front of and behind the equipment.

Currently, seven hi-rail vehicles have been retrofitted with the new lighting package. Nine other hi-rail vehicles are also slated to receive the upgraded lighting package. Priority for the lighting package upgrade will be based on need and the use of the hi-rail vehicle. The lighting package will include a backup camera and a dashboard-mounted internal monitor, upgraded lights, and shunt straps. (See figures 5, 6, and 7.) The approximate cost to upgrade the existing hi-rail equipment is \$4,000 per vehicle.

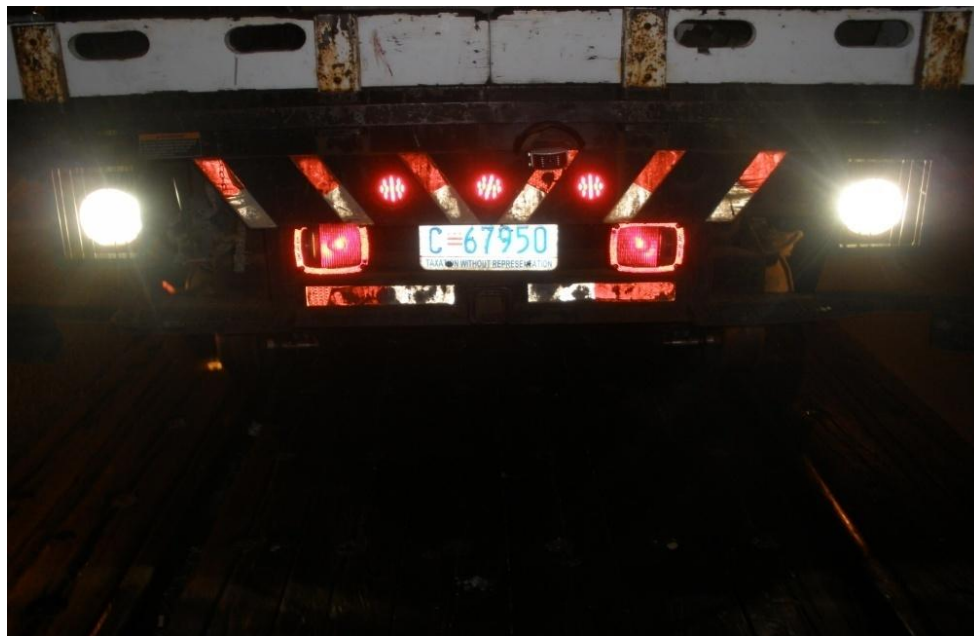
Figure 6. Rear view of a hi-rail vehicle with an upgraded lighting package.

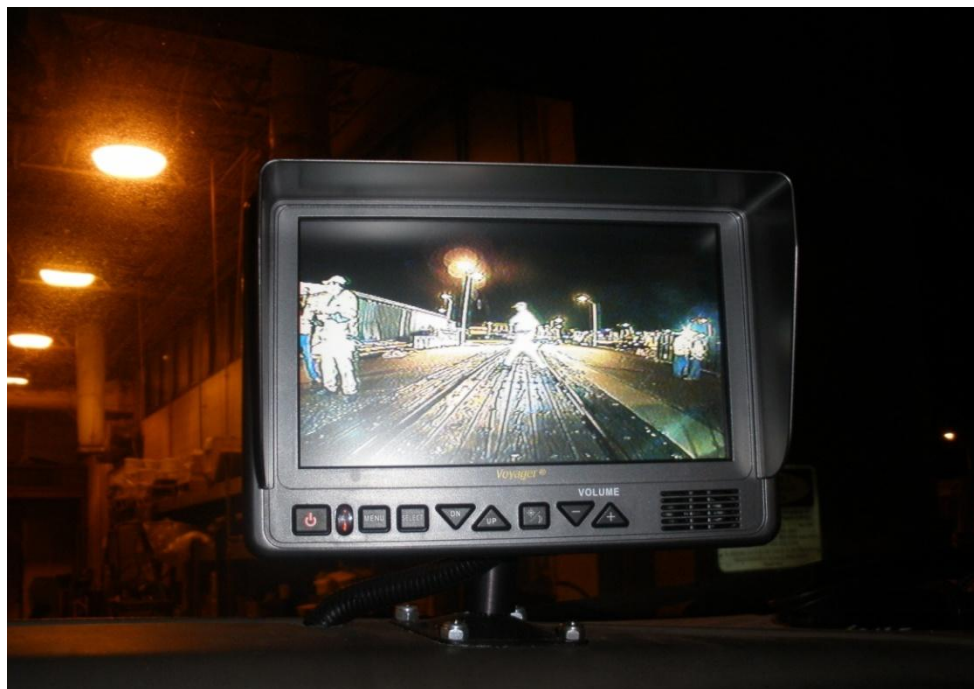
Figure 7. Video screen for backup movements in a hi-rail vehicle retrofitted with the upgraded lighting package.
