# Aviation Investigation Preliminary Report

| <b>Location:</b> | Jersey City, NJ | <b>Accident Number:</b> | ERA25MA171 |
| <b>Aircraft:</b> | Bell 206L-4 | <b>Injuries:</b> | 6 Fatal |

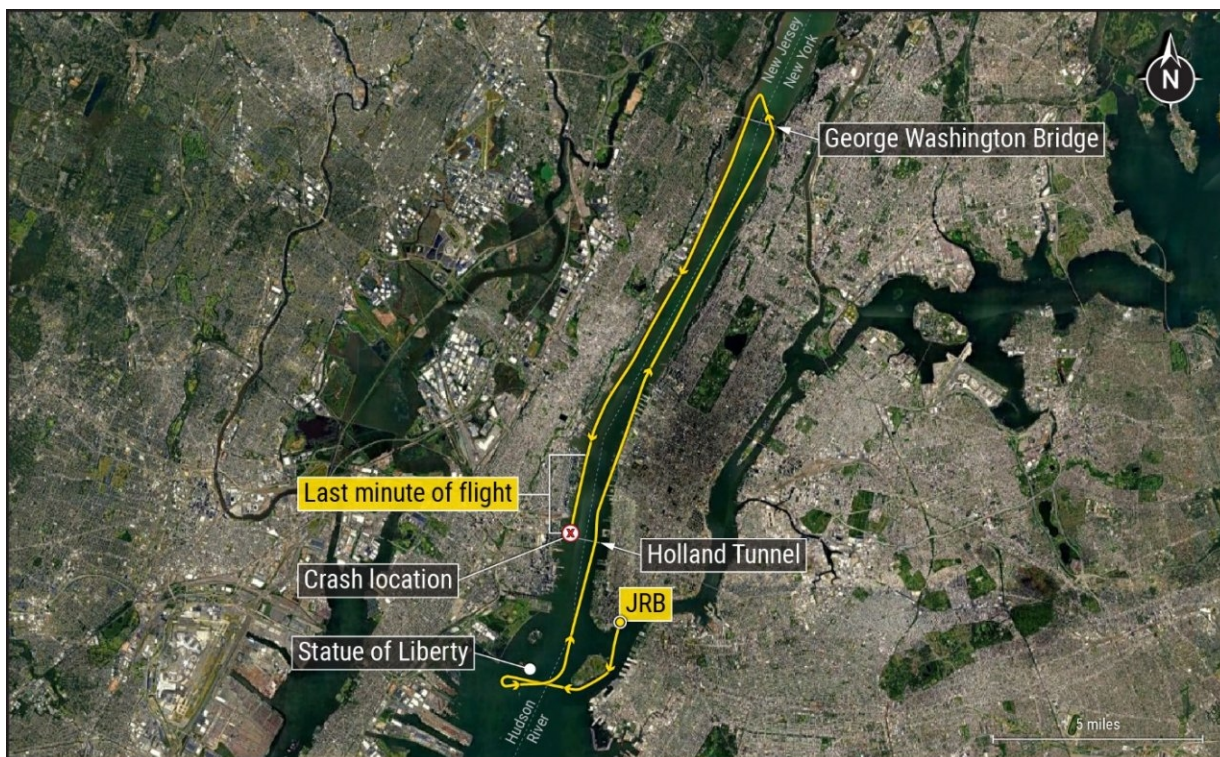
Preliminary Automatic Dependent Surveillance-Broadcast (ADS-B) flight track data obtained from the Federal Aviation Administration (FAA) revealed the helicopter departed Downtown Manhattan/Wall Street Heliport (JRB), New York, New York, about 1458. The helicopter flew a teardrop pattern south of the Statue of Liberty, then proceeded north along the east side of the Hudson River adjacent to Manhattan, past the George Washington Bridge, where it performed a u-turn, then headed south along the New Jersey side of the river (figure. 1).

**Figure 1. ADS-B flight track overview of entire route of flight from takeoff through loss of signal near the accident location.**

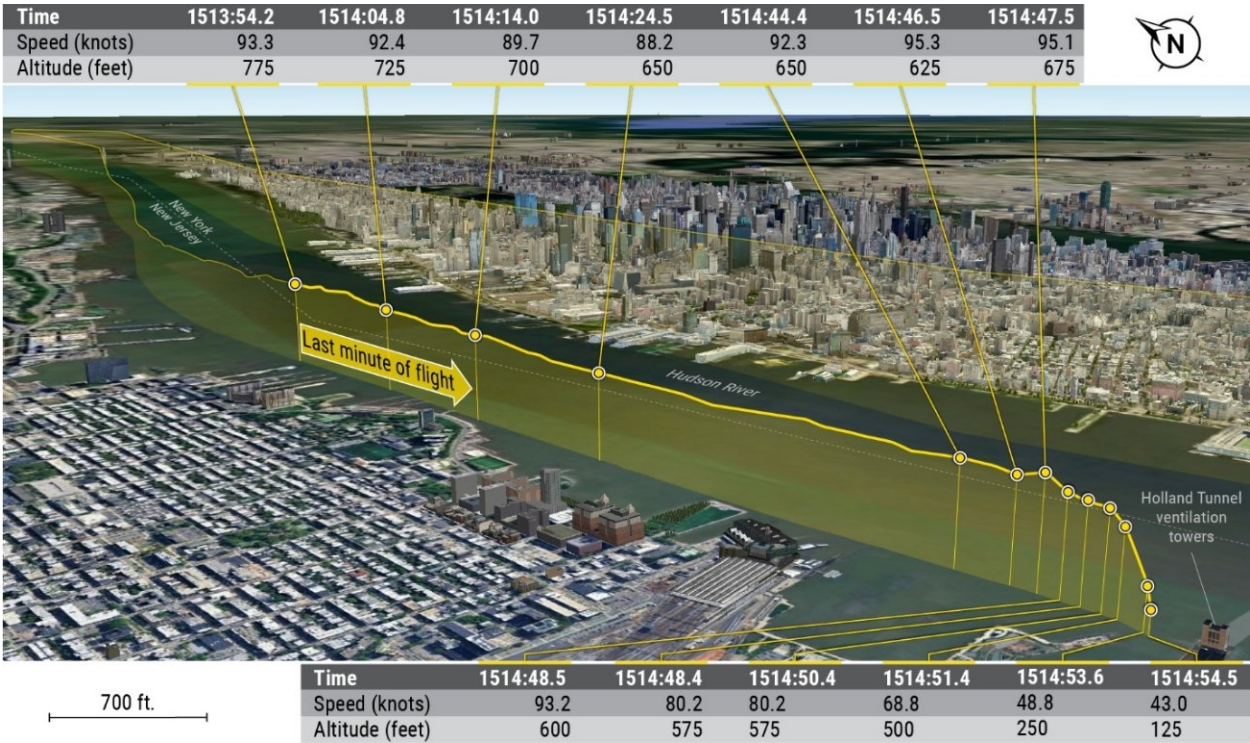
Figure 2 depicts the plot of the helicopter's ADS-B-observed flight path for the final 1 minute of flight, with the reported time, altitude and groundspeed superimposed. As the helicopter approached the Holland Tunnel ventilation towers near Jersey City, New Jersey, it was at a geometric altitude between 625 and 650 ft. The helicopter's altitude increased to 675 ft msl

before it entered a rapid descent. The data ended at 1514:54.5 and the helicopter’s last observed altitude was 125 ft.

**Figure 2. ADS-B flight track and geographic data highlighting the last minute of the flight through breakup, uncontrolled decent and loss of signal.**

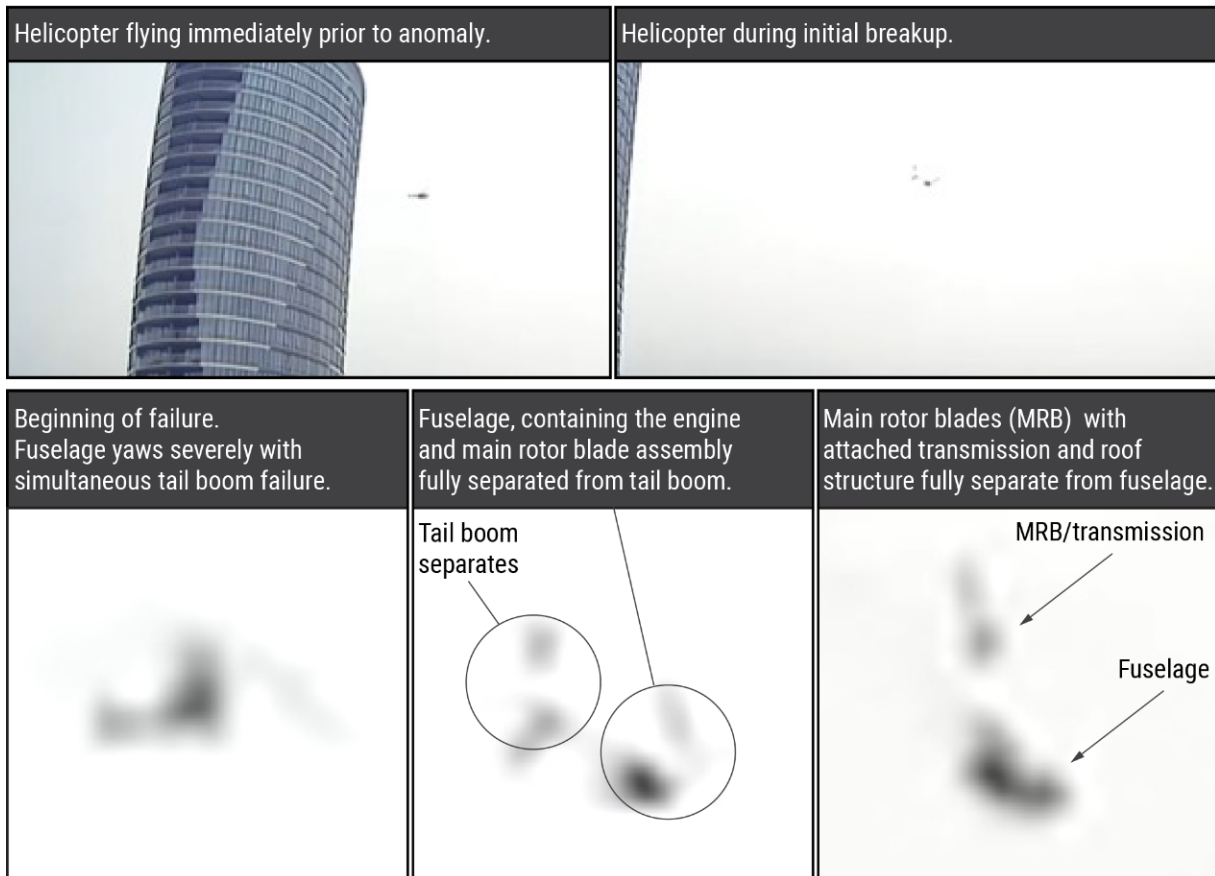
Several witnesses described hearing several loud “bangs” emanating from the helicopter before it broke up and descended into the river. Surveillance video (with accompanying audio) captured the helicopter traveling south before it suddenly separated into three major sections: fuselage (including the engine), main rotor system (including both main rotor blades, transmission and roof-beam structure), and the tail boom (including the tail rotor) (figure 3).

**Figure 3. Enhanced surveillance video with sequential images depicting the helicopter's flight and breakup.**

The fuselage came to rest, inverted, north of the Holland Tunnel ventilation towers where the water depth was about 6 ft. The main rotor and tail boom sections were found north of the fuselage and were submerged to a depth of about 30 ft. Debris was also recovered from the surface of the river and from a rooftop near the Hoboken, New Jersey, transit building.
